# ETR Laboratories

## Miscellaneous Scan Report

## Asbestos Report #2224117

### No Asbestos Found

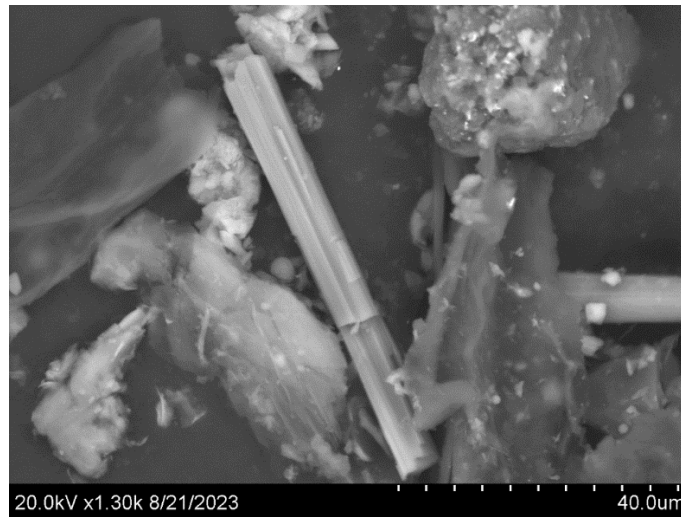
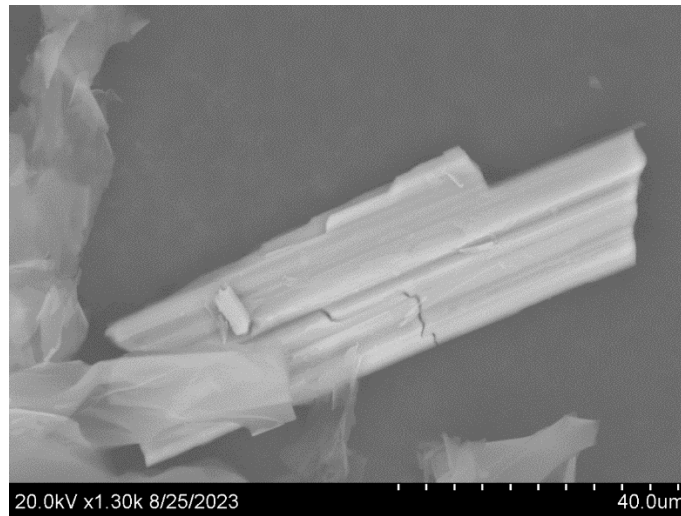
**Figure 7- Reference images of asbestos seen on SEM.**
